IR Case Study

LA-1600 Group
Breaker

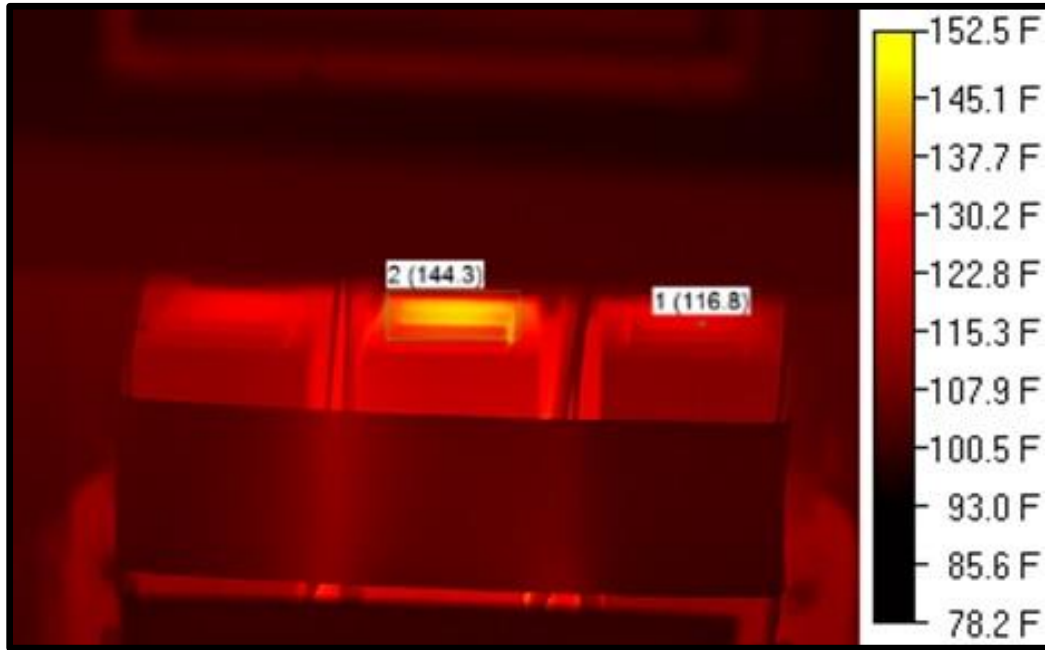
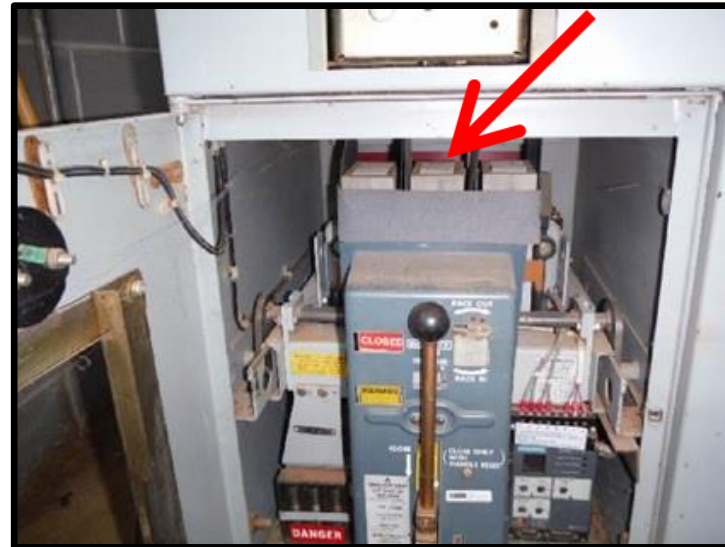
900 - 1,000 Amps

B-Phase Arc Shoot had
a ΔT of 28°F

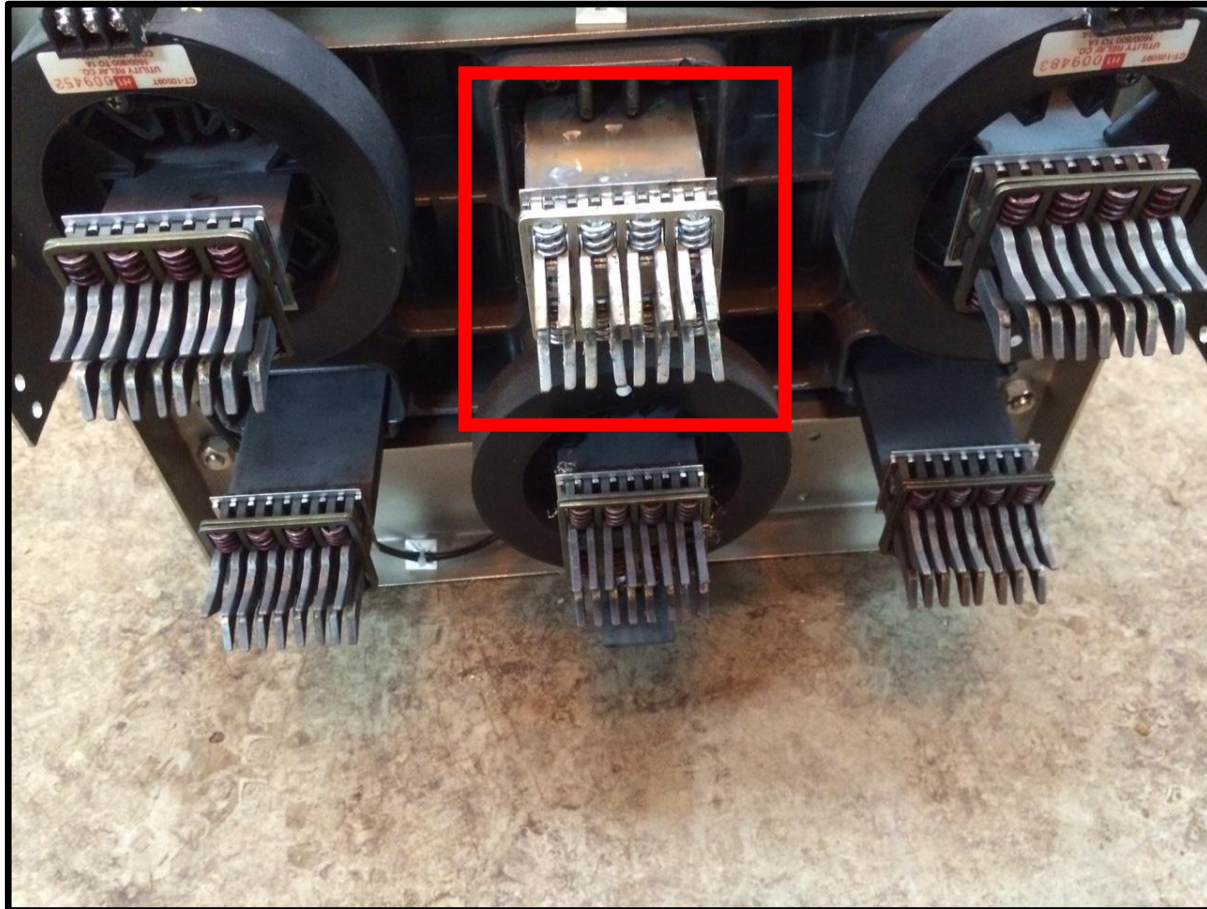
B-Phase showed a significant amount of heat discoloration on the line side pole projection.

Noted that finger cluster was plated, which would damage the springs

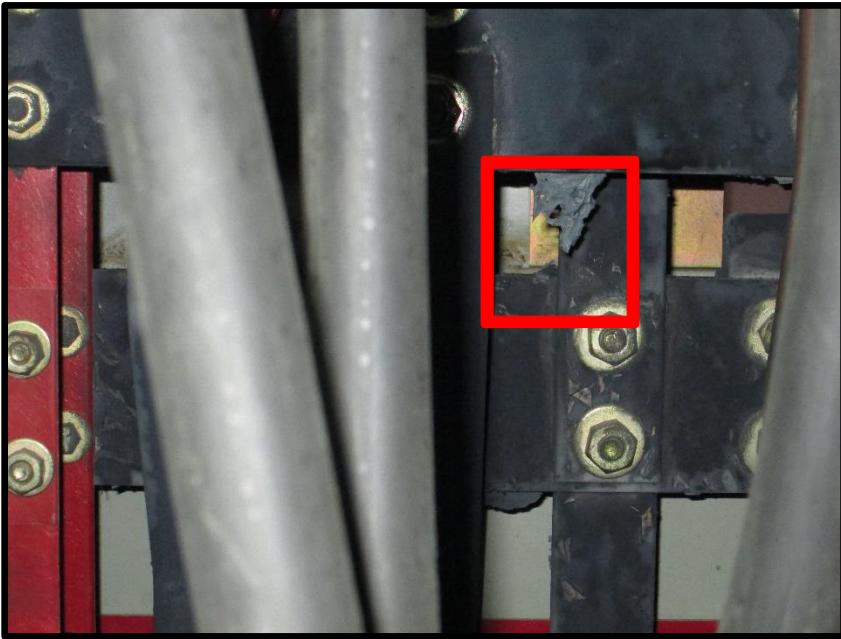
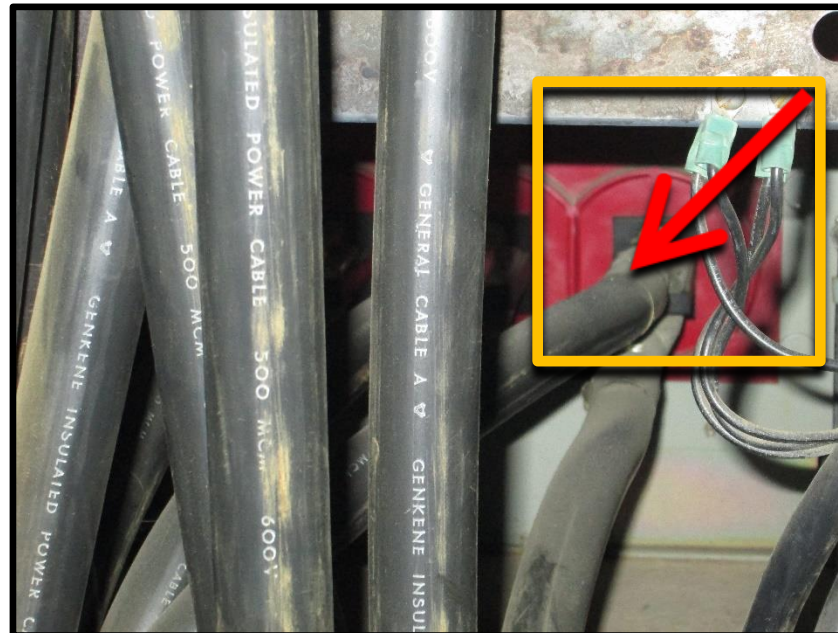
Buss Bars had severe scaling and flaking

Metallic Dust buildup noted on wiring insulation

H₂S Gas @ 2.3 ppm
