CASE STUDY

Vibration Increase in a Liquid Ring Compressor

By Charles Scott
TNT Reliability Services, Inc.

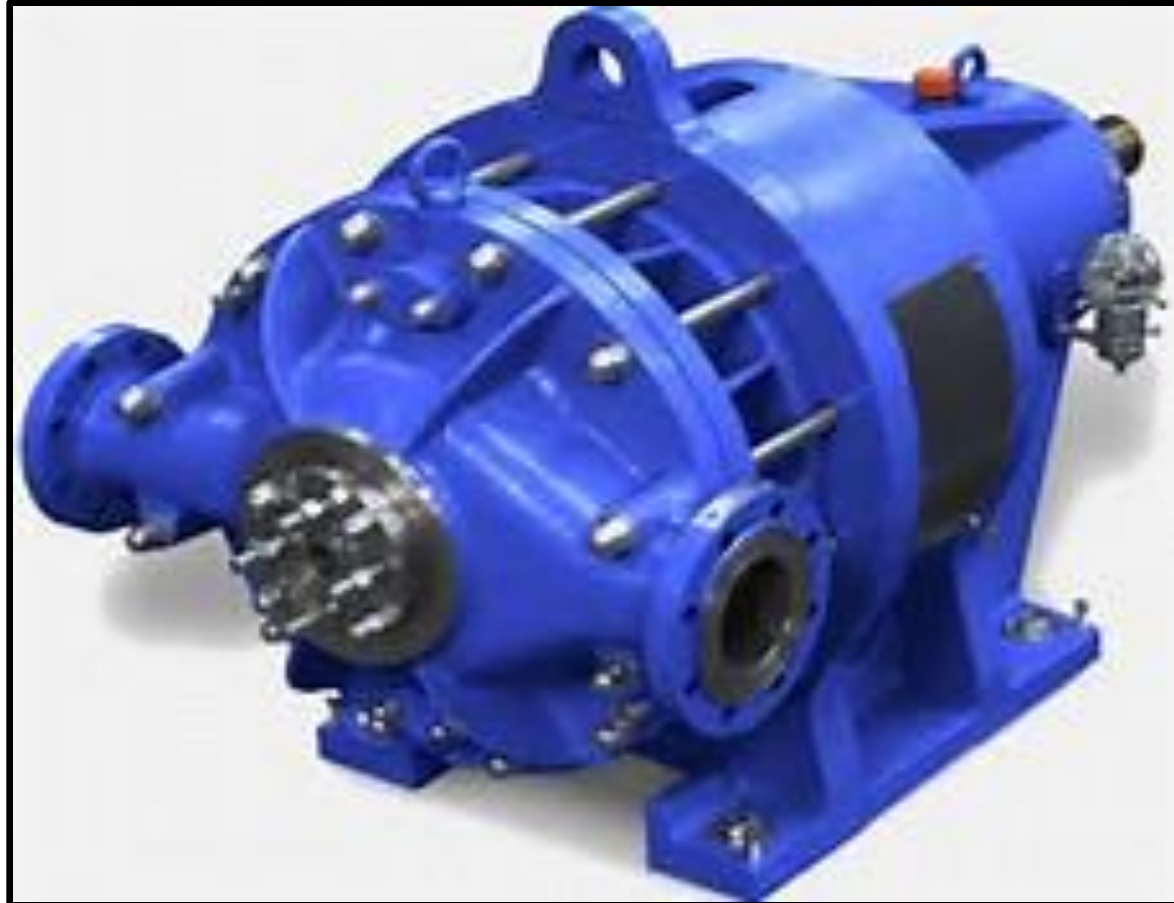
Liquid Ring
Compressor

Capacity of 795 cfm &
Differential Pressure
of 78 psi

1200 rpm

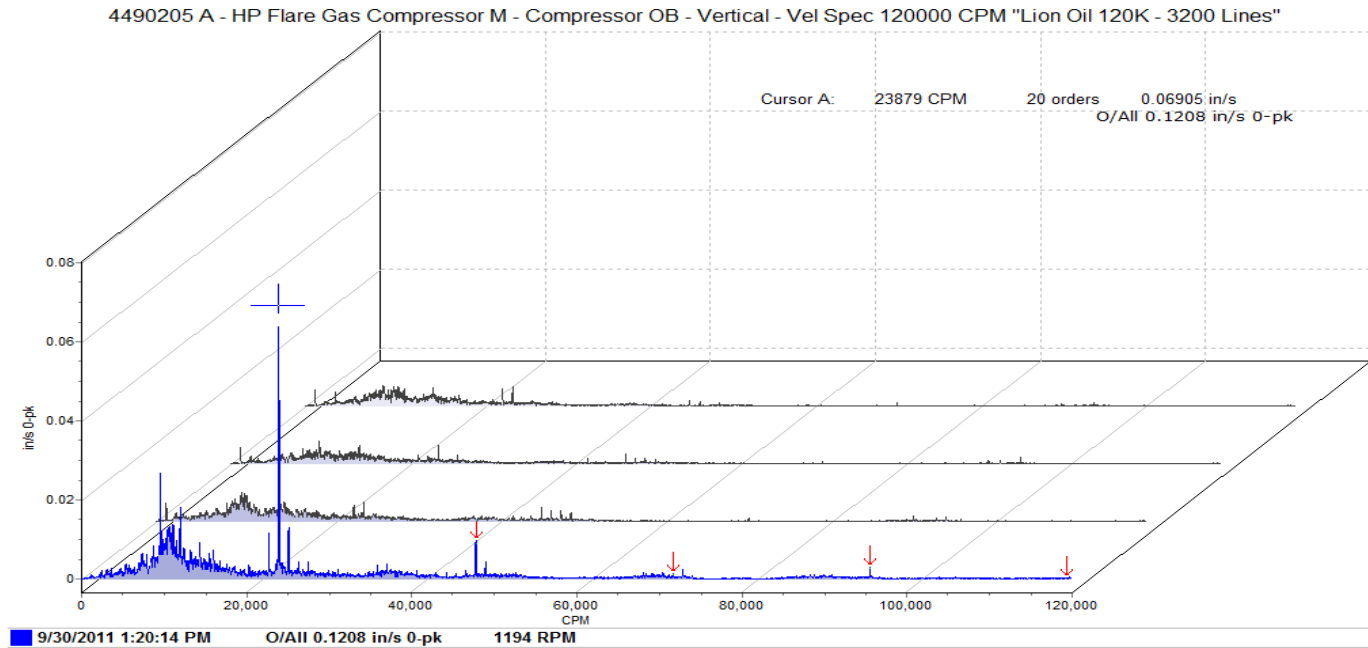
Increase In Vane Pass Frequency & Harmonics

Energy in Time-Based Waveform Increasing

Overall Vibration Amplitude Still Considered Low at 0.12ips

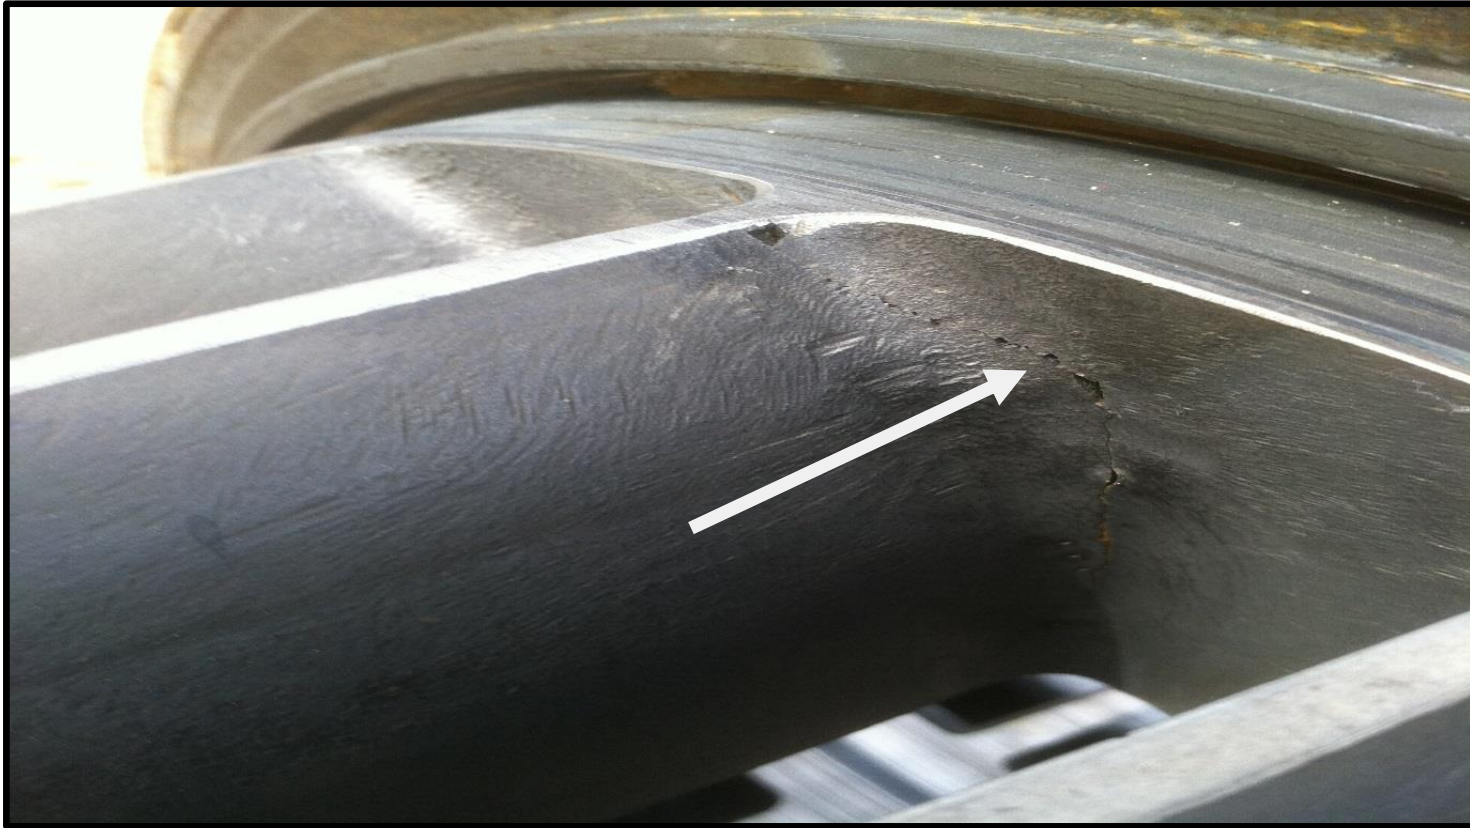
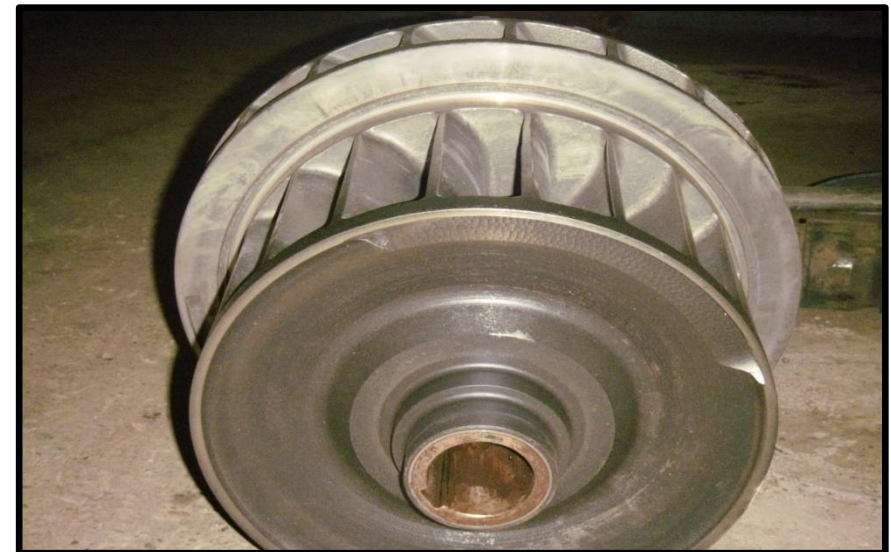
Maintenance history of the liquid ring compressors: previously, an impeller vane had broken completely off, wedging it inside the fluid end of the machine and causing a catastrophic failure. The damage caused by the component failure resulted in a total loss of the machine. The replacement cost for this machine was \$360,000, with a six-month lead time.

By finding the problem predictively, rebuilding the compressor was only \$60,000. Proactive planning due to predictive knowledge resulted in a savings of approximately \$300,000.
